Pedestrian Mobility and Safety Audit **Tucson, AZ, USA**

Executive Summary

South 9th Avenue and West Irvington Road Pedestrian Crossing

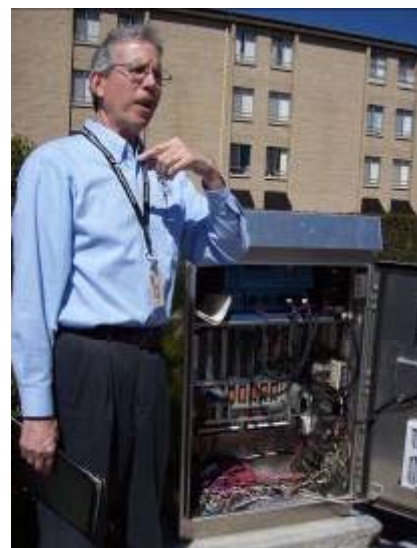
Richard Nassi shows the inside of the traffic signal controller at the Fellowship Square/ 8200 East Broadway Boulevard signalized HAWK pedestrian crossing to the audit participants.

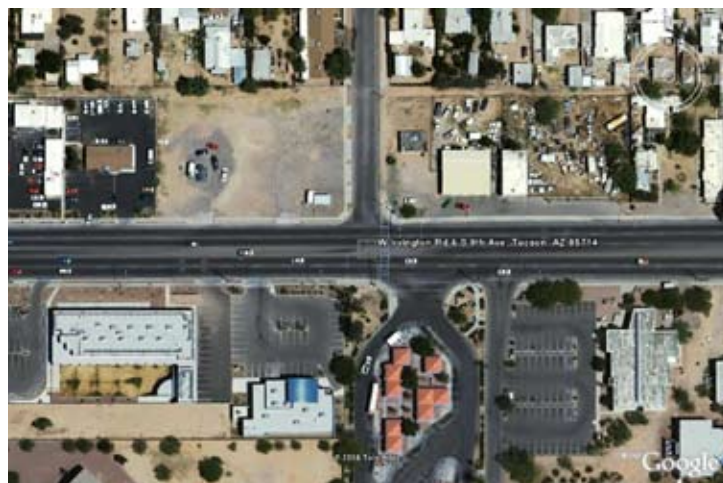
The total intersection volume is approximately 56,000 vehicles per day (vpd). The area as shown in the photo is low density suburban, and contains the adjacent Laos transit center. Irvington Road is a five-lane roadway (with a center left-turn lane). The pedestrian auditors believed that the traffic on Irvington was “civilized.”

Aerial photo of South 9th Avenue and West Irvington Road.

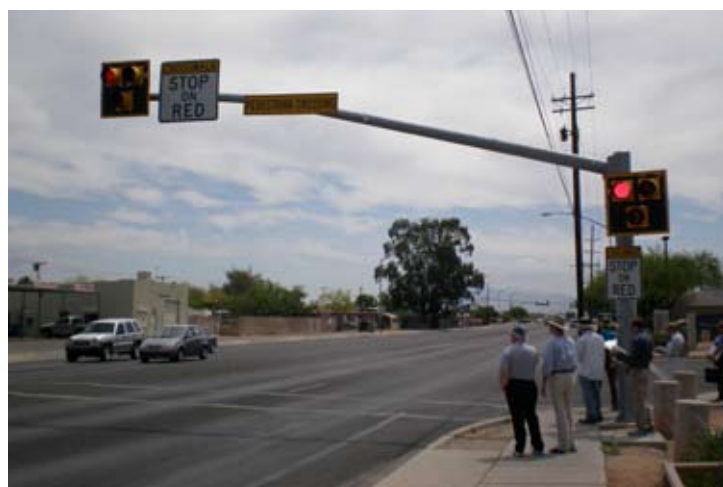
As shown in the photo, this style of pedestrian crossing signal is termed a high intensity pedestrian activated crosswalk (HAWK). The HAWK device is a specialized treatment for pedestrian crossings that is currently being considered for inclusion in the Manual on Uniform Traffic Control Devices. When not activated, the signal is “dark.” When a pedestrian pushes the button to cross, the following sequence begins:

1. The yellow light on the bottom of the signal head begins to flash for a short period while the DON'T WALK is displayed to pedestrians;
2. The yellow light is displayed steady (not flashing) for a short period while the pedestrians still have a DON'T WALK indication;
3. The red indications come on simultaneously and the WALK symbol is displayed to indicate to the pedestrian they may begin their crossing;
4. The red lights flash back and forth (similar to a railroad signal) and the FLASHING DON'T WALK with countdown timer is displayed to the pedestrian; and
5. The signal goes dark again and DON'T WALK is displayed.

In general, the review team felt very safe crossing at this location. Adequate time is given for pedestrians to cross and the countdown signals were very helpful. There was some concern about the potential for people using walkers, canes, or wheelchairs negotiating the crosswalk due to uneven and rutted pavement. In the short-term, the following recommendations should be considered to improve the safety of the intersection:

A HAWK pedestrian signal.

- **Improve** pedestrian accommodations by repairing cracked sidewalks, addressing ruts and other pavement issues.

- **Completing sidewalks** on the north side of 9th Street.
- **Trim** trees that block signage and the signal at the intersection.
- **Intersection pavement markings have faded.** The lines in the street need painting, especially for older eyes to see. The city paints the lines on the road every six months; however the sun is a factor that causes the lines to fade very quickly (sometimes in a matter of weeks).
- **Install** detectable warning surfaces to enhance the safety for visually-impaired pedestrians.

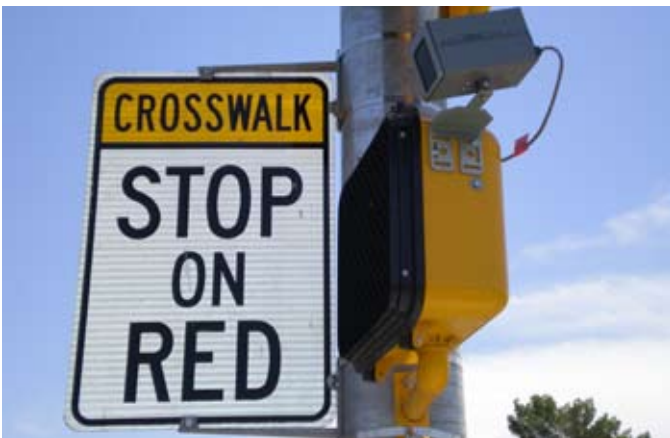
As shown in the first photo below, this style of pedestrian crossing signal is termed pedestrian user friendly intelligent crosswalk (PUFFIN). The PUFFIN signal is nearly identical to the HAWK signal in that the sequencing of the signal operation is the same. The primary difference is that the PUFFIN signal has a device that is able to detect the speed at which pedestrians are walking in the crosswalk. This device—a microwave detector—

A microwave detector mounted on a pedestrian indication at a Puffin Signal.

determines if the pedestrian will not complete the crossing in the allotted time. If it determines that more time is needed to complete the crossing, it will give additional time before the signal goes dark for vehicular traffic.

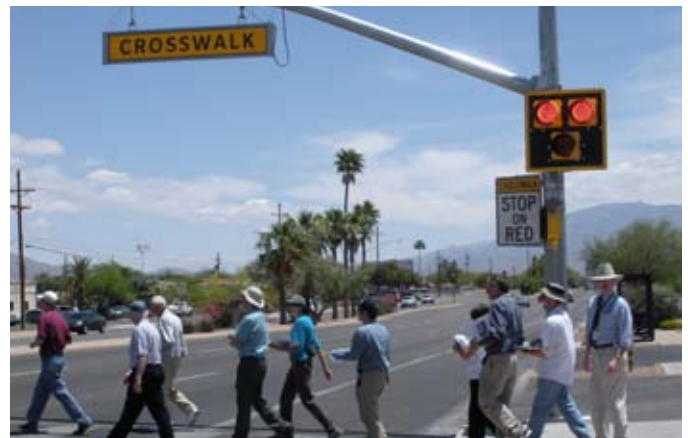
The pedestrian auditors walking within a crosswalk that has a HAWK signal at 8200 East Broadway Boulevard.

The review team felt reasonably safe with the signalized crossing at this location. No serious deficiencies were noted in the short-term.

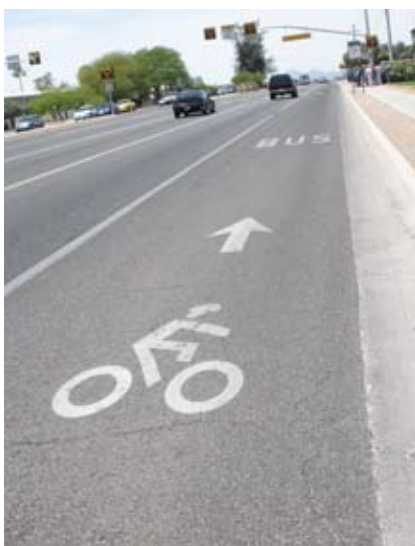
A marked BUS and BICYCLE ONLY lane in the right-curb lane approaching the mid-block HAWK signal.

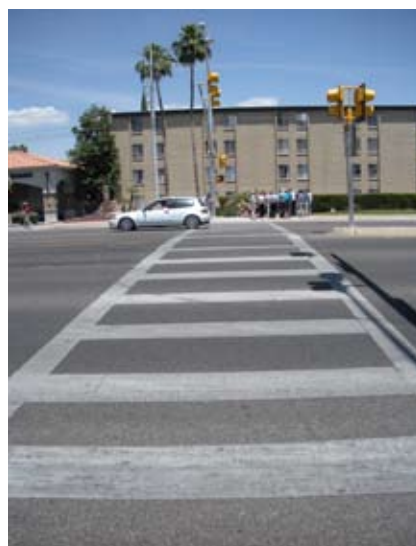
A zebra or ladder crosswalk at the HAWK signal.

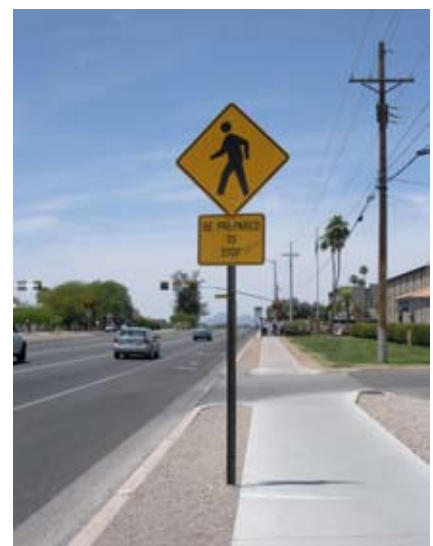
BE PREPARED TO STOP pedestrian sign prior to the HAWK installation.

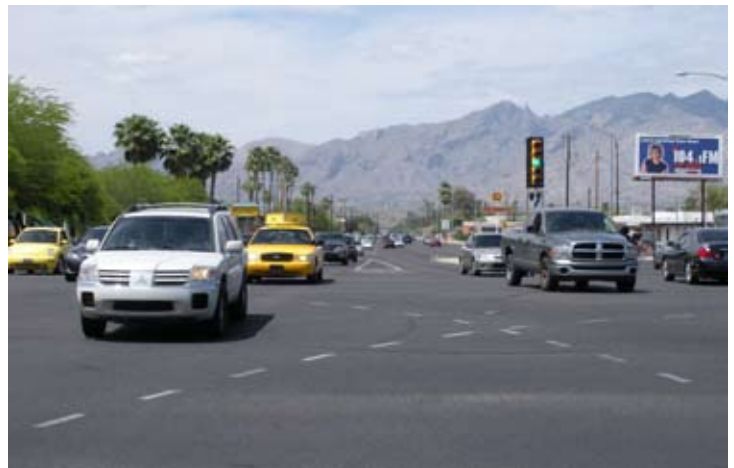
This intersection is a typical four-leg signalized intersection. The total intersection volume is approximately 83,400 vehicles per day. Speedway Boulevard is a major east-west cross street in the city of Tucson.

The combination of a short-cycle length and very wide streets made traversing the entire crosswalk in one stage very difficult, especially for older pedestrians. To counteract this, the crosswalks were cut through medians with a separate pedestrian push button located on a pole in the median. However, several on the review team felt extremely uncomfortable being “stranded” in the median while waiting for the WALK indication to come again so they could complete their crossing.

North Alvernon Way and East Speedway Boulevard is a high-volume intersection that serves many vehicles. Look how much pavement there is. “Puppy tracks” direct turning vehicles. The pedestrian auditors believed that the vehicles at this intersection behaved in a “civilized manner.”

- **Repaint** crosswalks that have fading paint.
- The team believed that not much could be done to the intersection operations because of the way the intersection is designed. The pedestrian auditors acknowledged that the intersection operates quite well considering that it needs to serve multiple users in addition to large traffic volumes as shown in the photographs on the next page.

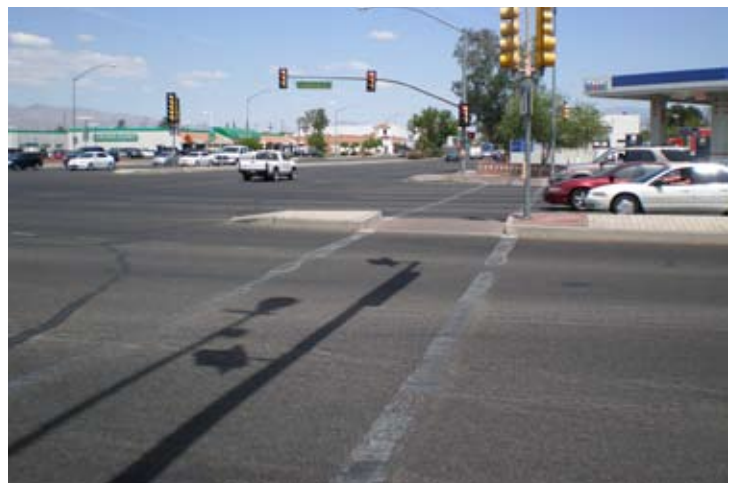
A cut-through median at the intersection.

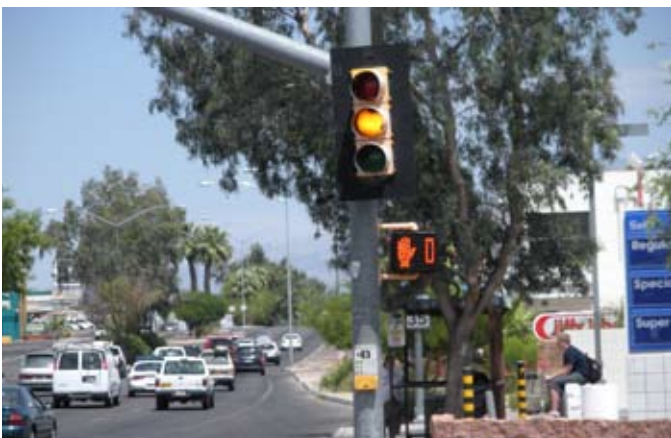
Pedestrians are assisted with crossing the intersection through the use of pedestrian countdown signals.

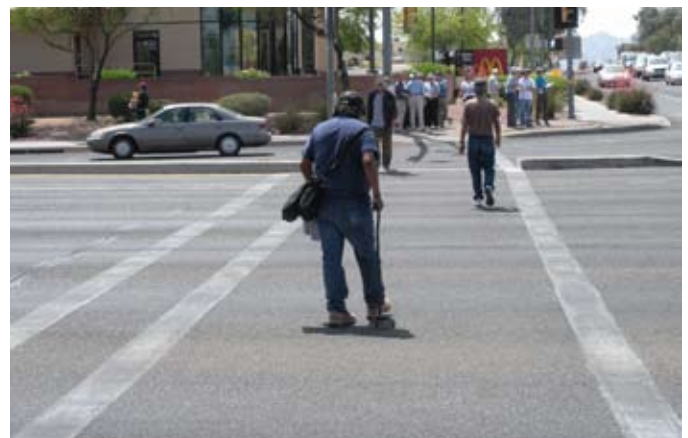
Pedestrians with disabilities are accommodated.

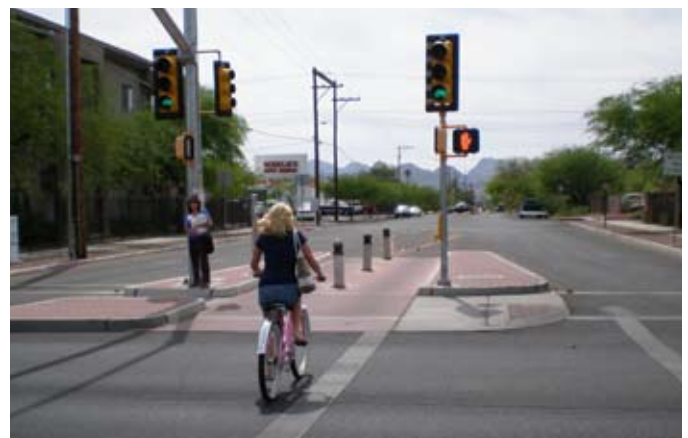
In keeping with the theme of naming treatments for birds, this style of traffic signal is termed a TOCAN, an abbreviation for the phrase “two can cross.” The “two” refers to the pedestrian and bicyclist groups, each of whom has their own signal indication for crossing the street.

A bicyclist crossing at a TOCAN signal.

safety improvements. It was noted that a few drivers approaching on the side street violated the right-turn only and instead went through the intersection.

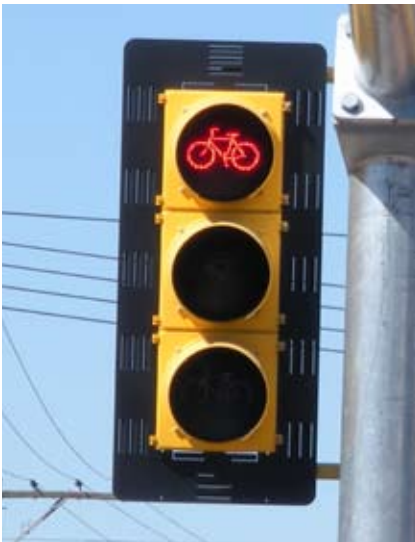
- Notice the bicycle icon on the traffic signal in photo A below.
- Environmental comfort: transit stops and benches are located within the intersection environment, as seen in photos B and C. As a positive, benches that are there are being used as shown. As a negative, notice how close the benches are to the roadway.
- Notice that the bicycle is being lifted and placed on the bus in photo D. This is an example of multi-modalism.
- Notice the distance between the roadway and the sidewalk in photo E. This makes for a comfortable walking environment for all users.
- Notice the “bus pull out” along University Boulevard in photo F.

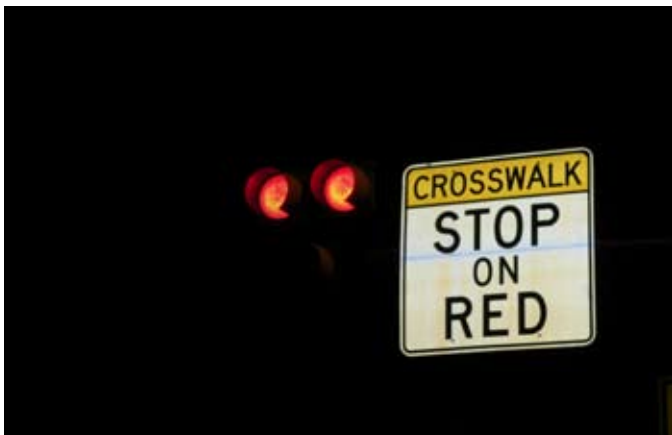
Illuminated signing at night is particularly helpful for older persons. The signs below are illuminated at pedestrian crossings.

Nighttime illumination sign at a HAWK signal.

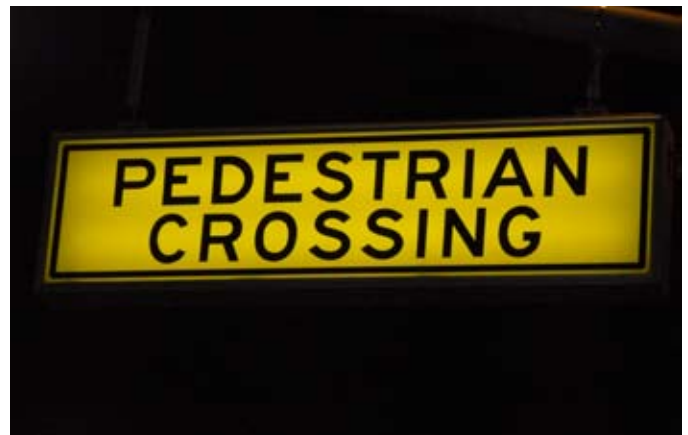
Nighttime illumination PEDESTRIAN CROSSING sign.

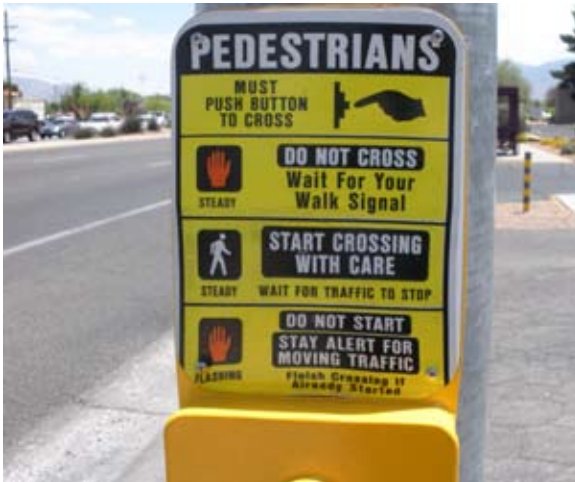
The city of Tucson uses yellow, black and white instead of the standard black and white signs for the explanation of pedestrian push button plaques to assist people to cross the street at signalized intersections (see the photo on the left). The photograph below on the right is a traditional pedestrian push button plaque.

Easier to read pedestrian crossing signs used by City of Tucson.

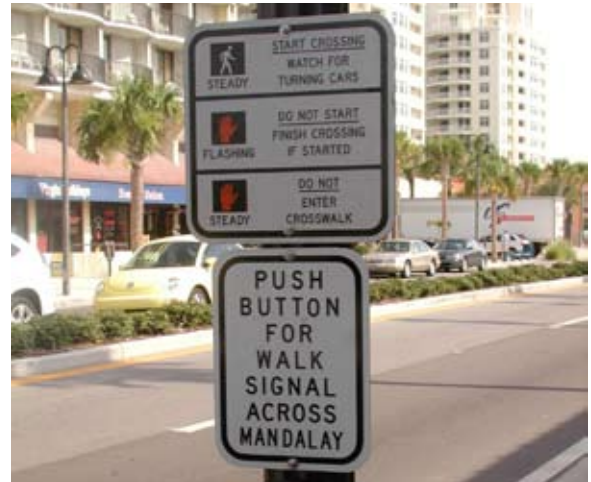
Traditional pedestrian crossing sign used in many U.S. cities.
